ATM SAFETY
AND NIGHTTIME
LIGHTING SURVEY

Bank Name ATMID: 107

3530 S. Main St. Salt Lake City, UT (40.7302,-73.63535)

Exterior · Walkup TTW · Diebold Nixdorf Opteva 562

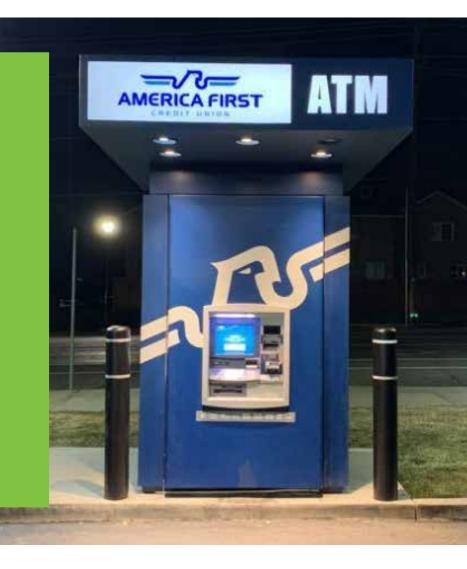
LIGHTING Failed

The illumination at or within five feet of the ATM or ATM entrance is less than 2 foot candles.

The illumination at or within 30 feet of the ATM or ATM entrance is less than 2 foot candles.

The illumination at or within 50 feet of the ATM or ATM entrance is less than 2 foot candles.

Within the parking area the illumination at or within 60 feet of the ATM or ATM entrance is less than 1 foot candles.

Lights Not Working

| ltem No. | Туре |
|---|---|
| 1 | Wall Light |

Lights Replacement: None

Reasons Light(s) not replaced Lights Not Replaced as Part of this Survey
